TS-AMD-87615-25
May 1988

AERIAL PHOTOGRAPHIC ANALYSIS OF THE REFINED METALS CORP.

Indianapolis, Indiana

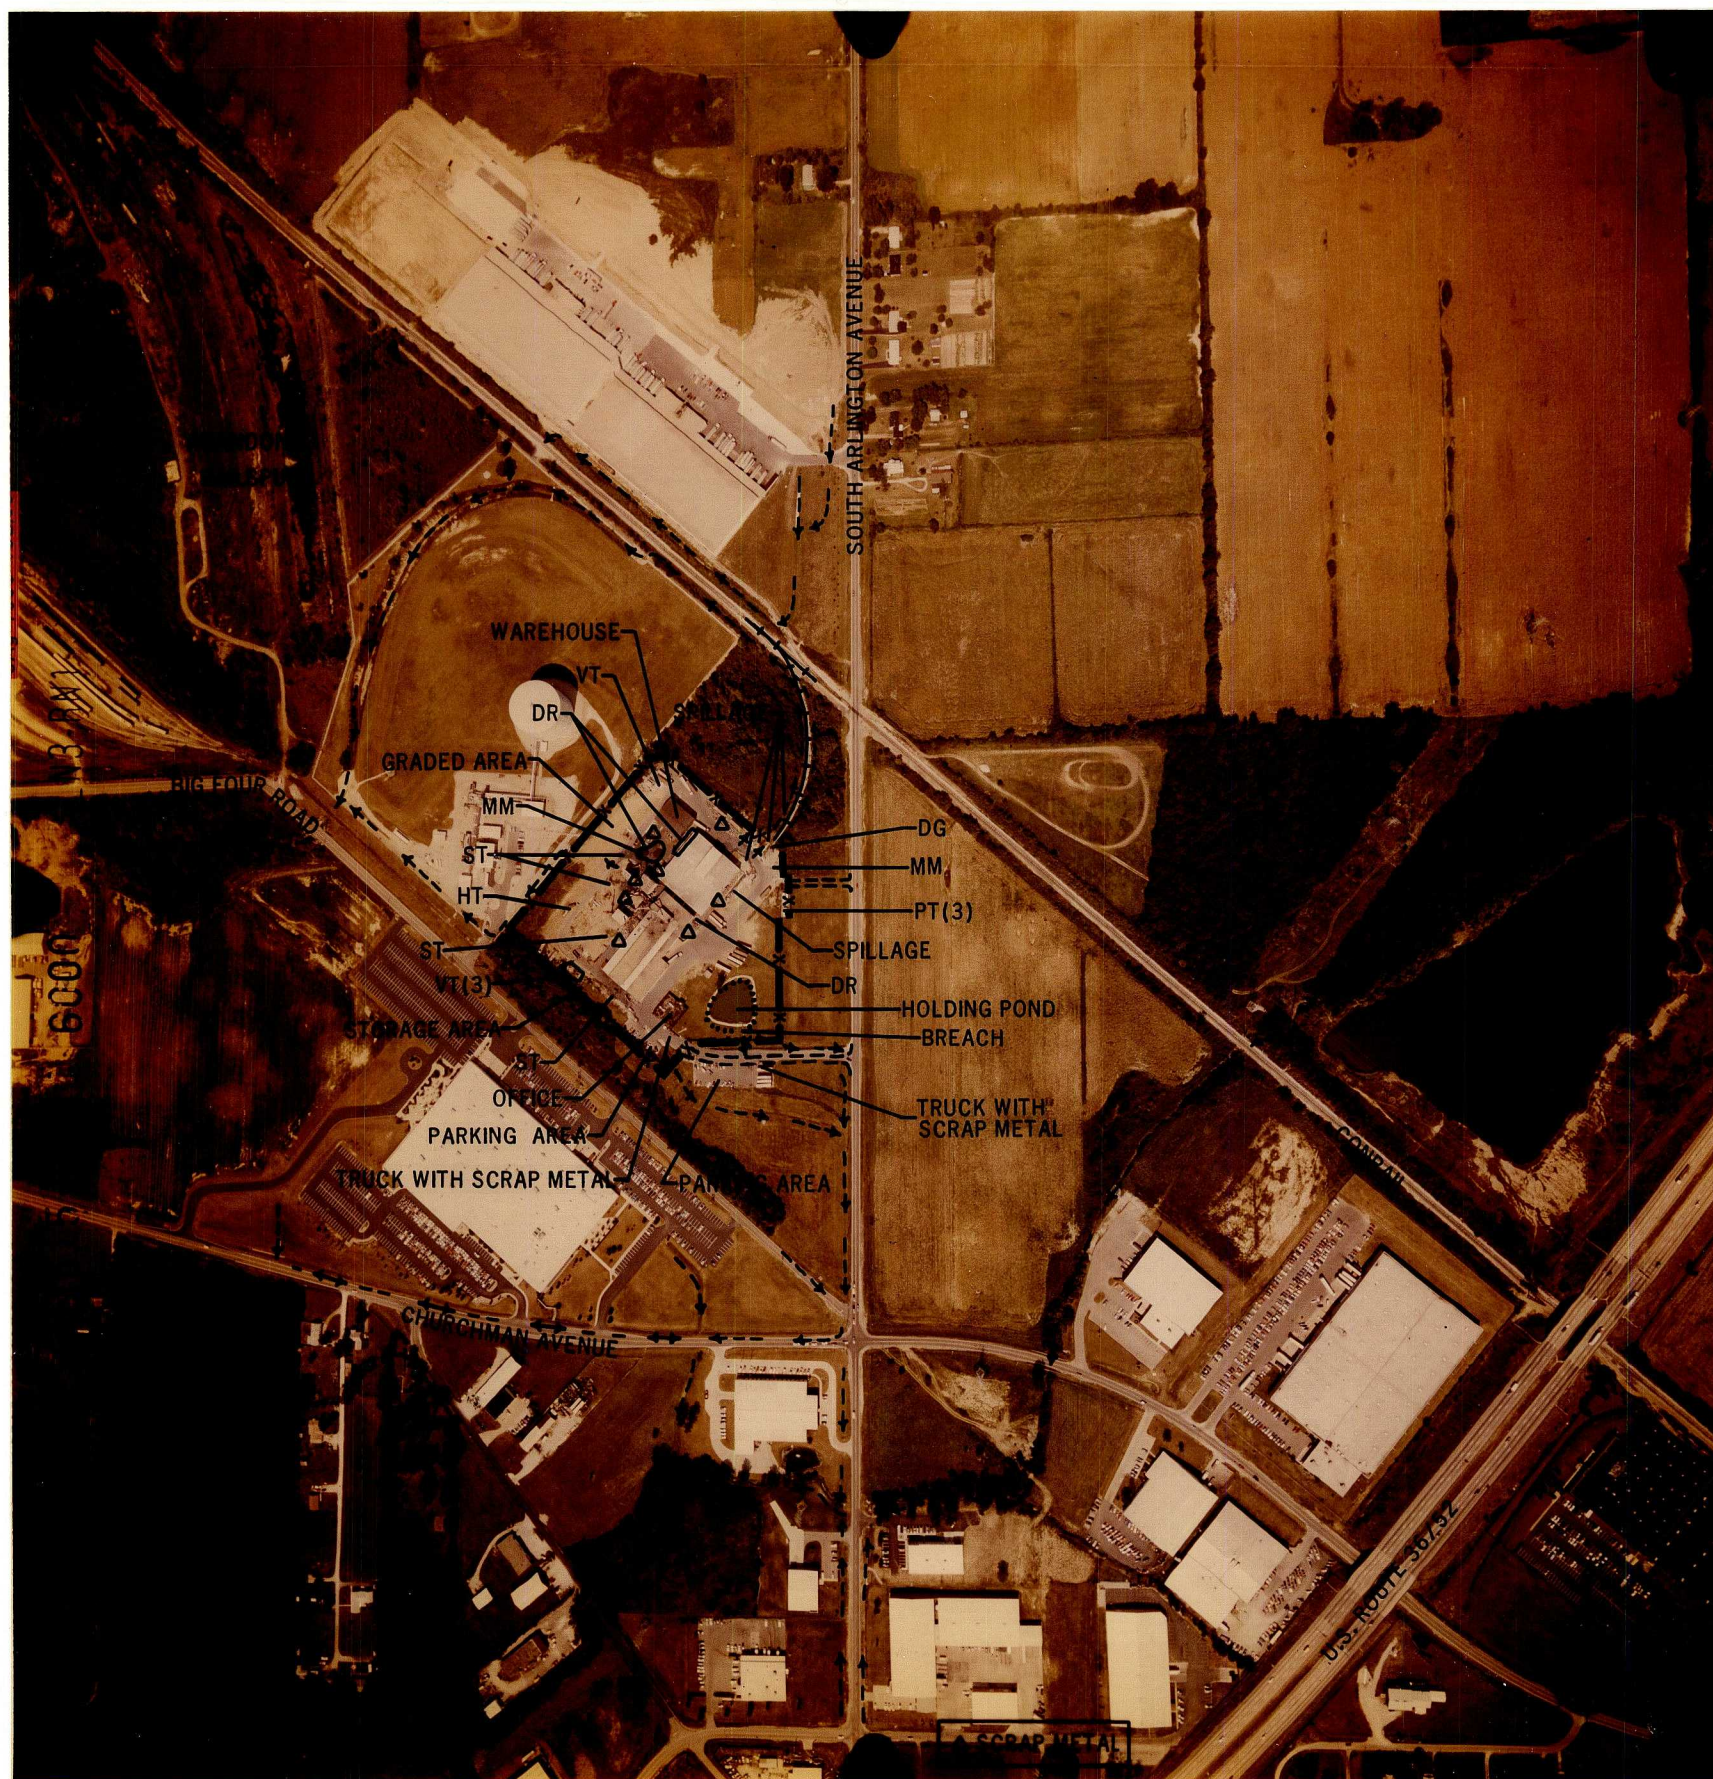
Figure 3. Refined Metals Corp., September 4, 1987. Approximate scale 1:6,000.

Surface drainage from the northern portion of the facility would be to the north toward Beech Creek, and to the south toward Churchman Creek from the southern portion of the facility. Both Beech Creek and Churchman Creek flow to the west where they eventually empty into Lick Creek.

Access to the fenced facility is from the east via South Arlington Avenue.
